# Drying out, drawing plans, *and* doing it right: *Rebuilding and Repairing Old Capitol*

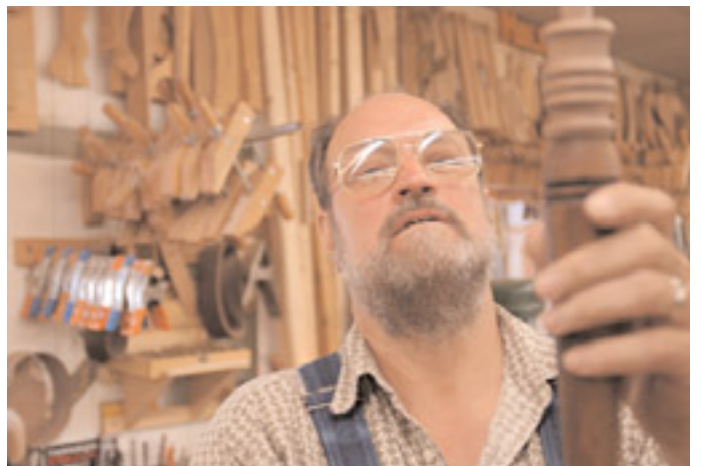
*Left:* The Old Capitol fire interrupted a restoration project. Work has resumed, and soon the west portico will be refurbished, the exterior masonry restored, and the windows repaired. *Above:* Experienced hands repaired furniture damaged in last November's Old Capitol fire. Norman Schantz, of Schantz Furniture in South Amana, has crafted many of the building's reproduction pieces over the years.

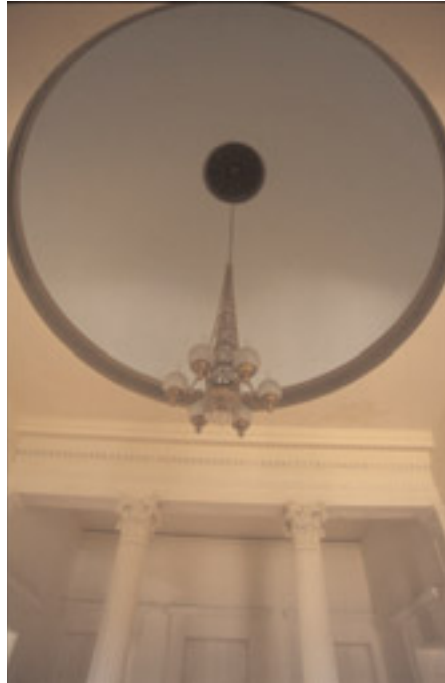
necessary, itemized, and packed for storage,” Smothers says. “For the first five weeks, we worked 16-hour days. All the carpets had to be cleaned, all the wall sconces were removed and cleaned and will require new wiring. Every day Tadd [Wiseman, the Old Capitol custodian] and I moved each of the four shutters on the 45 windows and all the doors, to keep them from warping.”

Water washed away the water soluble glue used on many pieces. The high humidity also raised the leather on the desktops in the House Chamber and warped the Supreme Court desk.

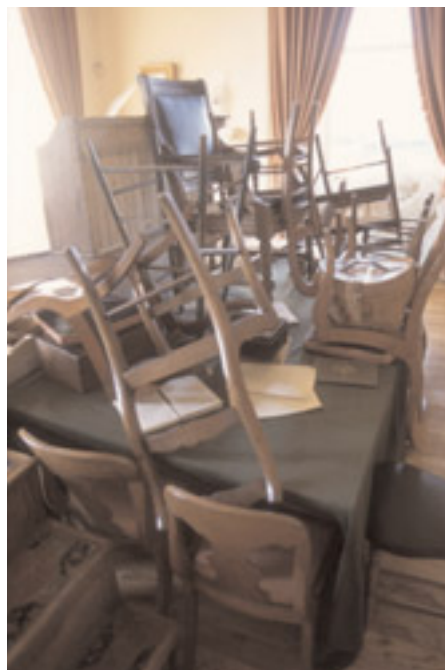
Assessing interior damage continues on an ongoing basis. As Old Capitol dries, cracks often appear in woodwork, walls, and columns. Fans have droned in the building since the day after the fire.

“It can take up to a year to dry out a building like this,” says Smothers, who points to the drainage holes drilled in the massive interior columns and walls. Floors that were badly warped are leveling out as they dry, however, and the reverse spiral staircase was recently load-tested for safety with 9,000 pounds of sandbags and deemed structurally sound.

*Top:* Because the exterior walls are limestone, the interior walls brick, and the floors concrete, it could take as long as a year for Old Capitol to dry. *Left:* More than 50 pieces of furniture, which at first seemed to have escaped largely unscathed, required repair.
